Service Insights

Geared Variable-Speed Drives | Power | Maintenance | AMERICAS

Support of a service provider for non-Voith equipment

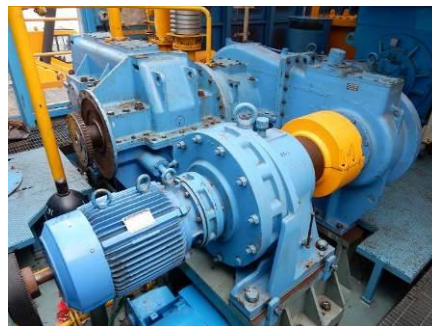
Torque converter with rotary device and gearbox

The units (torque converter, gearbox, including overrunning clutch) are disassembled, opened with special tools, cleaned and where appropriate,

equipped with new bearings. Non-destructive tests are carried out, for example, on the drive shaft, the hub and the bearings. Visual inspections, magnetic particle crack tests, mechanical concentricity tests, tothing backlash tests are carried out and the tothing contact pattern is also recorded.

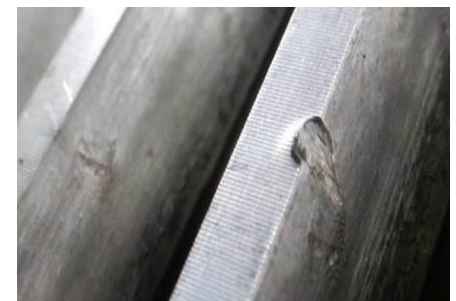
Detected damaged gearbox teeth

During the inspection of the gearbox, damage to the tothing was found, which was presumably caused by the passage of electrical current. The damaged parts are measured in 3D and manufactured by Voith. In June 2018,

these parts are installed on the plant by the service technicians. In August, the combined cycle power plant is back in operation.

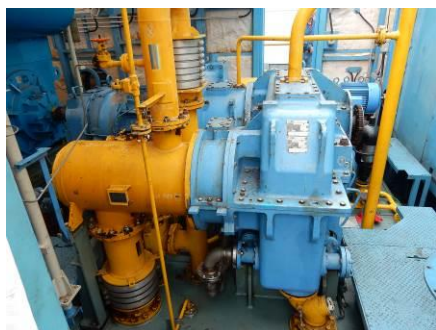
Gearbox of the Japanese original manufacturer

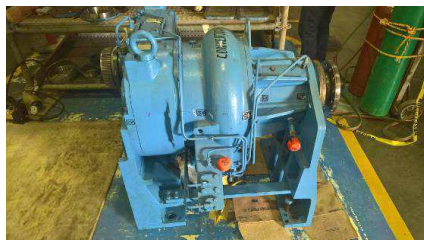
Torque converter manufactured in Japan

In the second operation, the spare torque converter is overhauled and installed in the second gas turbine line.
