Service Insights

Mitsubishi Planetary Gear, Type MIS 32/36X

Quick help with new wheel-set in old Mitsubishi gear housing

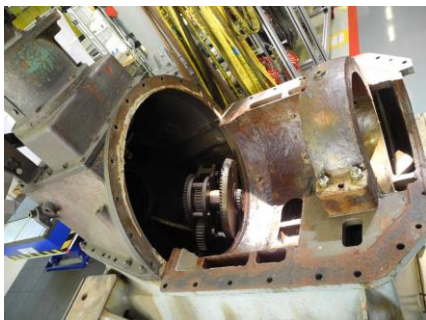
Condition of the planetary gear after delivery to Voith

Order: In the Mitsubishi gearbox, toothed parts were destroyed and thrown against the housing, which also damaged it. The inspection revealed a degree of damage that no longer allowed the wheel-set to be repaired. A new planetary gear had to be designed. In addition to restoring the system's functionality, it was also important for the plant operator to reduce the noise emission of the new gearbox.

In Germany, the old gearbox housing was 3-D measured in July 2015 in order to fit the Voith gear-set into the old Mitsubishi housing. The use of the old housing was also advantageous in order to be able to deliver the transmission to the customer in Russia through customs

as quickly as possible. The Mitsubishi housing was therefore repaired and overhauled.

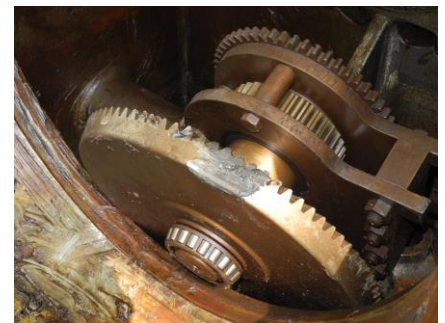
Damaged intermediate reduction gearing of the rotor turning gear

Technical Details: During the diagnosis, a defect in a tooth of a planetary gear was detected. The Voith service team identified this tooth fracture as a probable cause of the plant's uneven running.

What led to the total loss can only be assumed in the aftermath: It is highly probable that the screw connection has come loose from the countershaft of the rotor turning device. Thus the wheel fell on the fast shaft and shifted it axially.

The newly manufactured wheel-set was based on Voith's own high quality standard. Here, the set of wheels is case-hardened and can therefore withstand higher loads than the original nitrided material from Mitsubishi.
